Djebel Ouahch Tunnel

Constantine, Algeria

**Injection
& consolidation work**

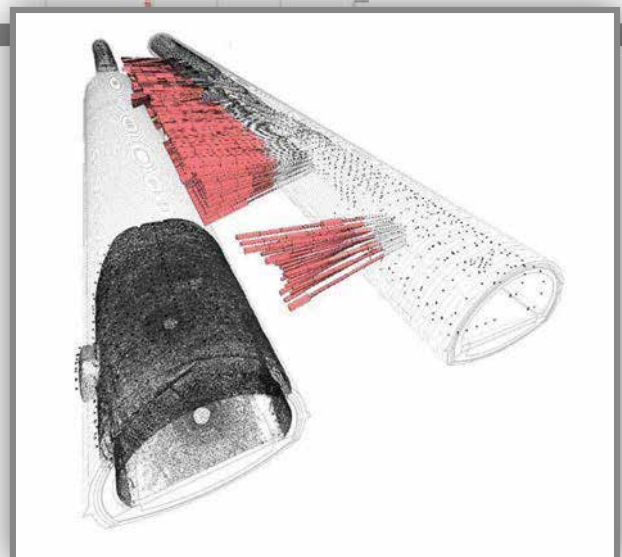
Consolidation works from the right to the left tube

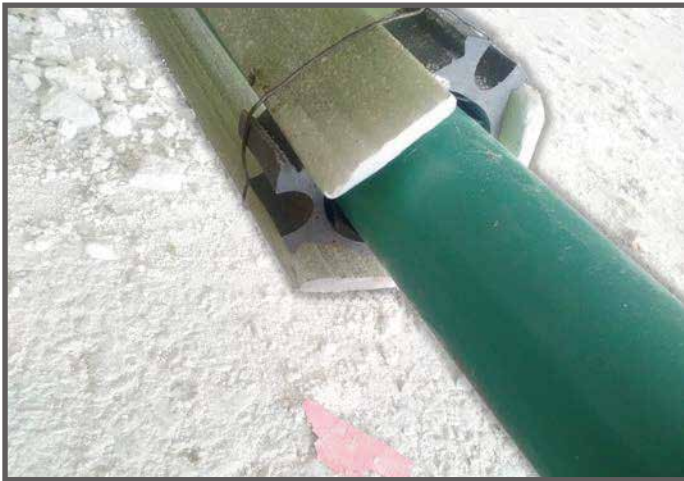
Fiberglass element used in phase 1 of the work

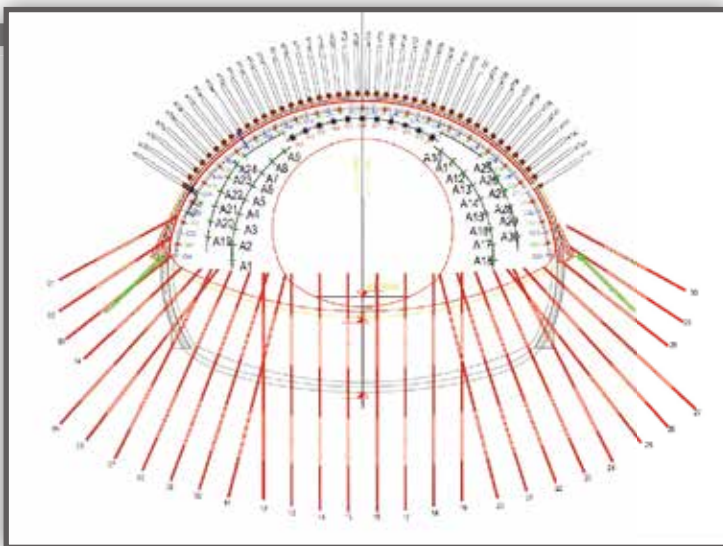
Enlargement section - Left tube

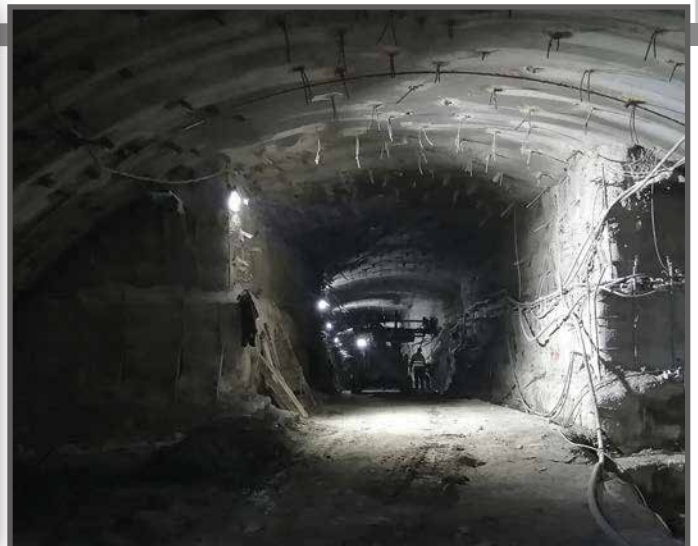
Niche zone - Right tube

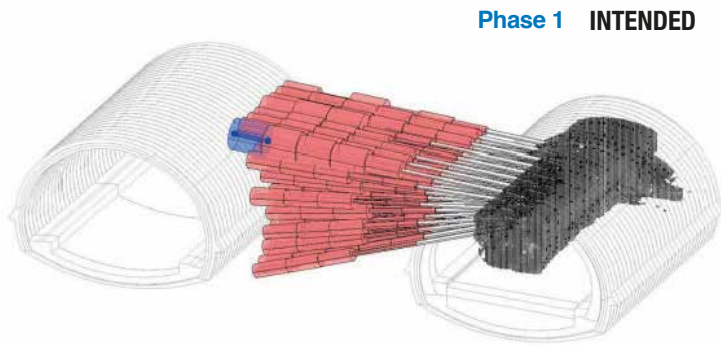
Strengthening the front with fiber-glassed bolts injected with cement grout

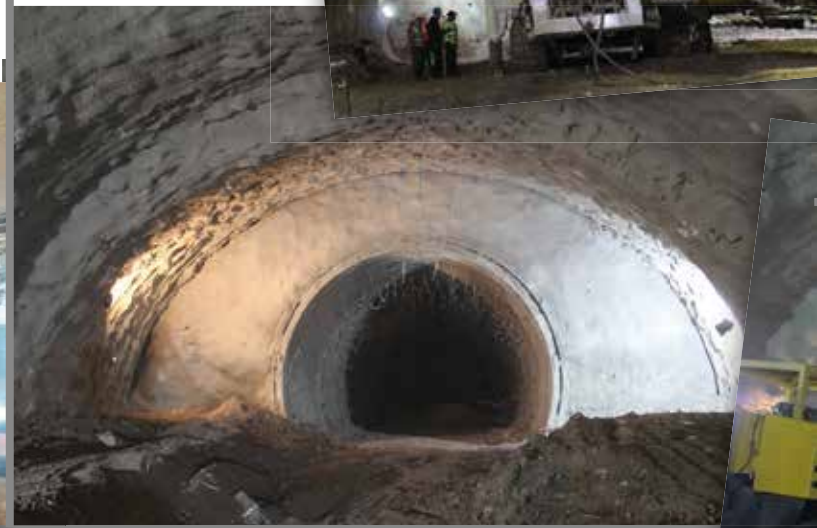
Phase 1 Top heading consolidation

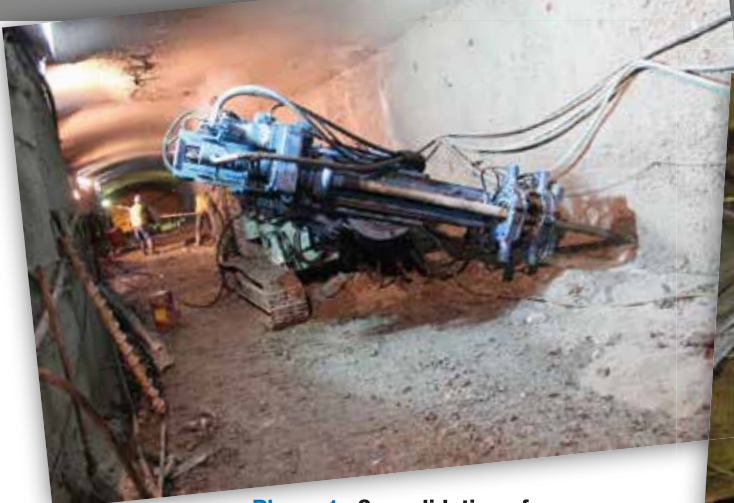
Phase 1 Consolidation of the zone between the tubes

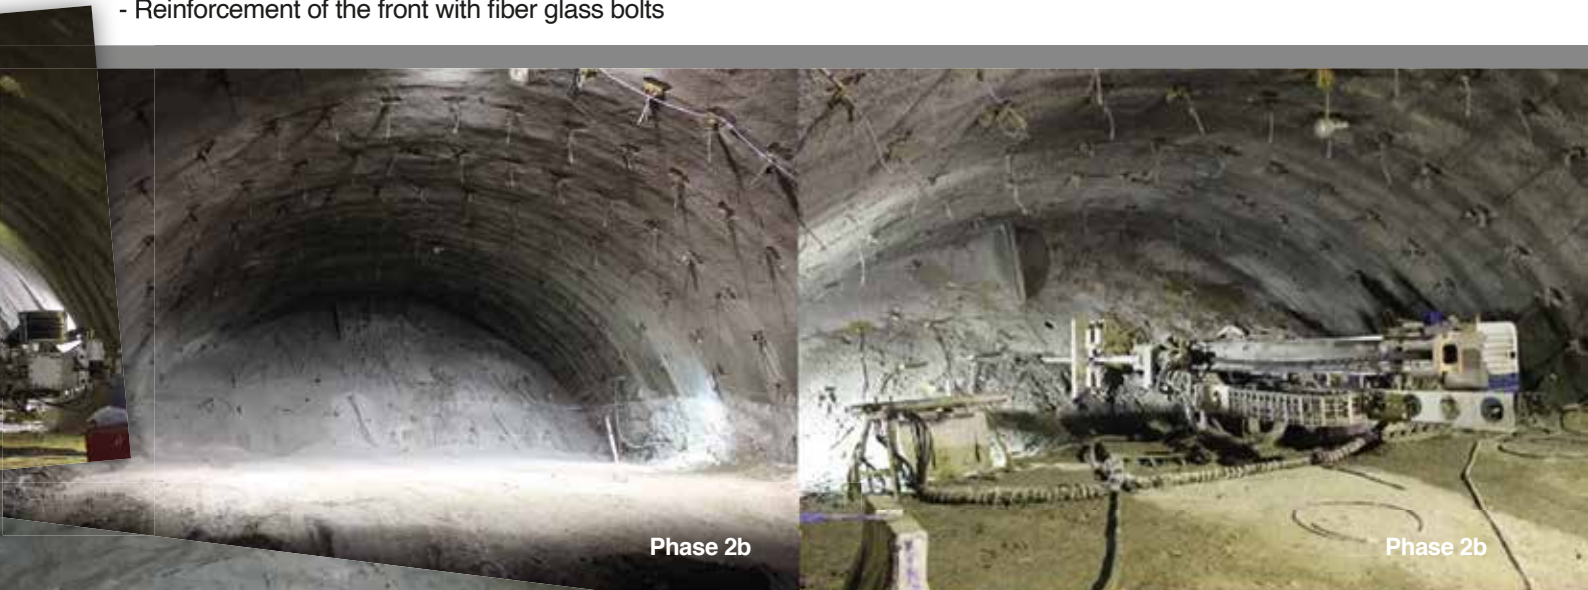
Strengthening and filling the collapsed front

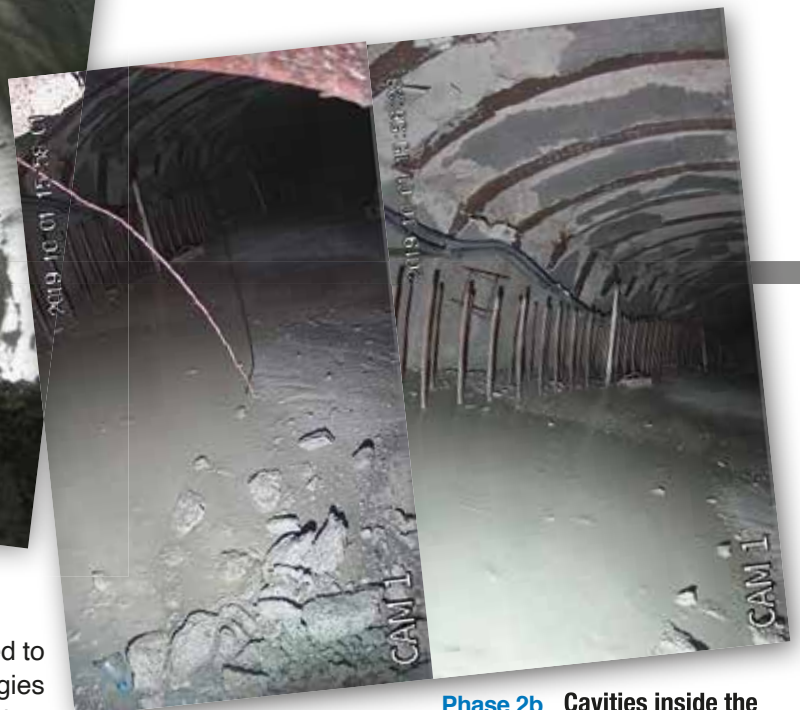
Phase 2b Cavities inside the collapsed area
